# Manhole Inspection Summary

Manhole # S33CC\_046MH

Insp Date: **3/20/08 8:53 AM**

**Location** Address: **1001 CATHEDRAL ST**

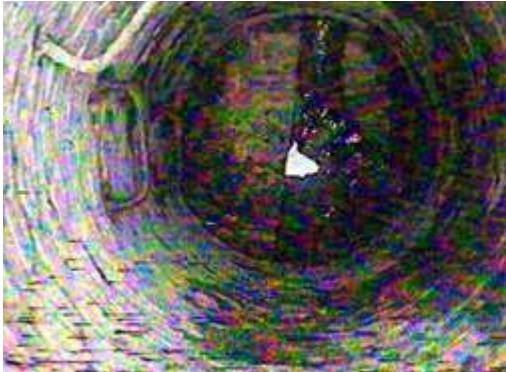
Defect 1

Count: **7** Missing: **0** ☒ **Corroded**

CORRODED STEPS

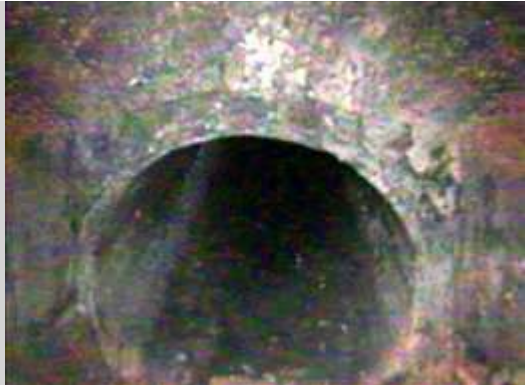
12 O'Clock Outflow

8 in. Circular Gravity Sewer  
Pipe Out @ 12 O'Clock

Invert Depth: **11.70** (ft.) Flow Characteristics: **Slow**

Infiltration: **None** Pipe Seal Cond: **Sound**

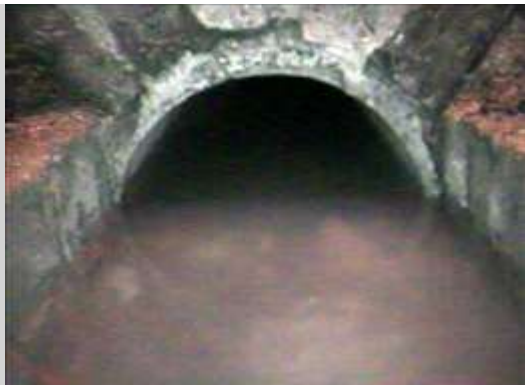
3 O'Clock Inflow

8 in. Circular Gravity Sewer  
Pipe In @ 3 O'Clock

Invert Depth: **11.56** (ft.) Flow Characteristics: **Slow**

Infiltration: **None** Pipe Seal Cond: **Sound**

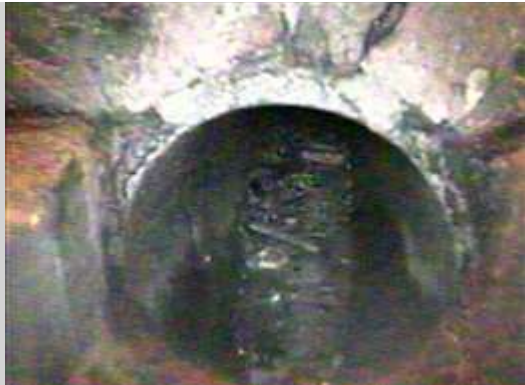
7 O'Clock Inflow

8 in. Circular Gravity Sewer  
Pipe In @ 7 O'Clock

Invert Depth: **11.24** (ft.) Flow Characteristics: **Slow**

Infiltration: **None**

Pipe Seal Cond: **Sound**
